RIVERBANK RESTORATION

IN THE MIDCOAST COUNCIL AREA

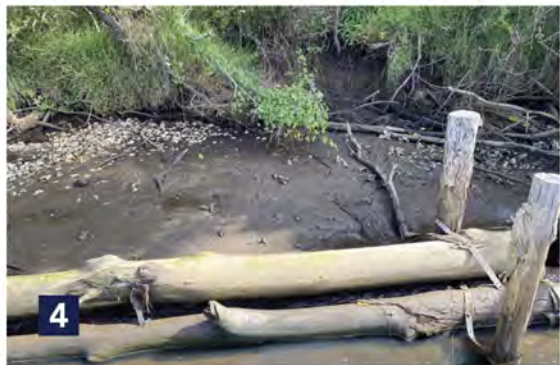
Figure 4 Oyster shell behind timber fillet, Wallamba River, April 2022. Note the sediment deposits [Photo Brian Hughes].

Oyster reefs can improve water quality, dissipate wave energy and stabilise foreshores. Discarded oysters from the production cycle (both live and dead) are reused and are placed behind the timber fillets. The survival of live oysters is being monitored, and studies have shown that the presence of oyster reefs and mangroves forests contribute to the abundance and diversity of fish species by providing nurseries and refuge from predators.

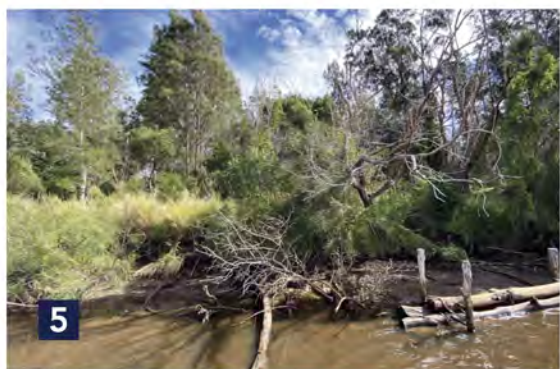
Figure 5 Sediment accumulating behind the fillet while the adjacent bank continues to erode, Wallamba River, April 2022 [Photo Brian Hughes].

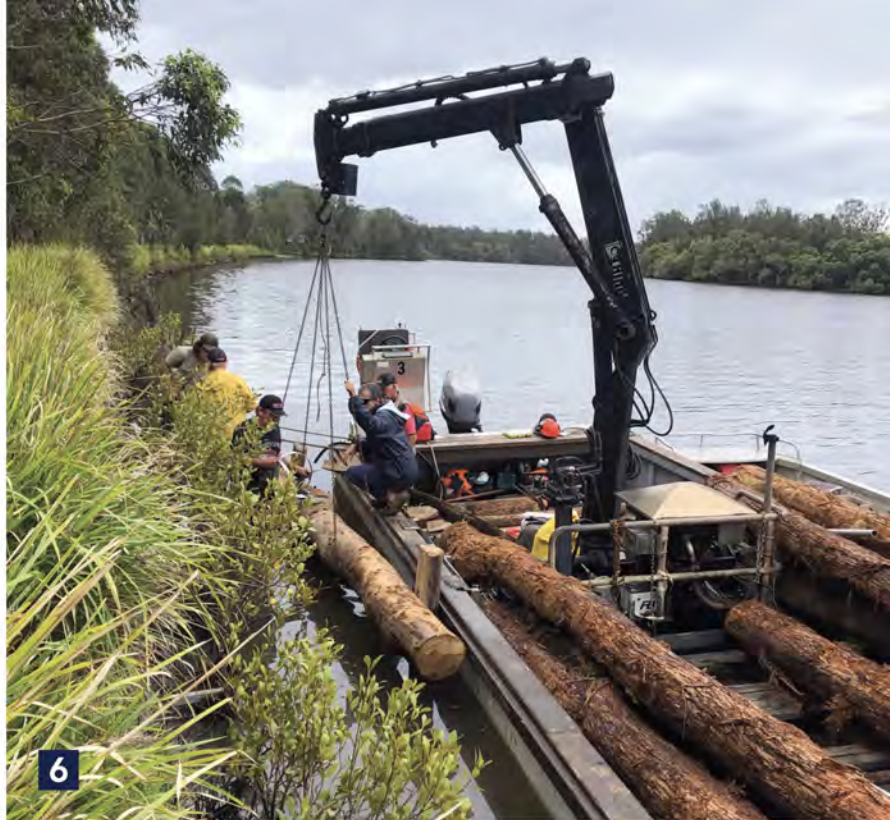
Figure 6 Horizontal log being craned into position [Photo Wade Lancett].

Logs 150-200mm in diameter and approximately 2-4 metres long are used for posts, and horizontal logs 350-600mm in diameter and up to 7 metres long are laid on top of each other to reach the required height for bank protection. The vertical posts are driven into the substrate and the horizontal logs are then secured to the posts and are referred to as timber fillets or large woody materials.
